Pursuing an After-the-Fact Permit using Atypical Wetland Delineation Methodology

Author: Hannah Comune

CEC
Civil & Environmental
Consultants, Inc.

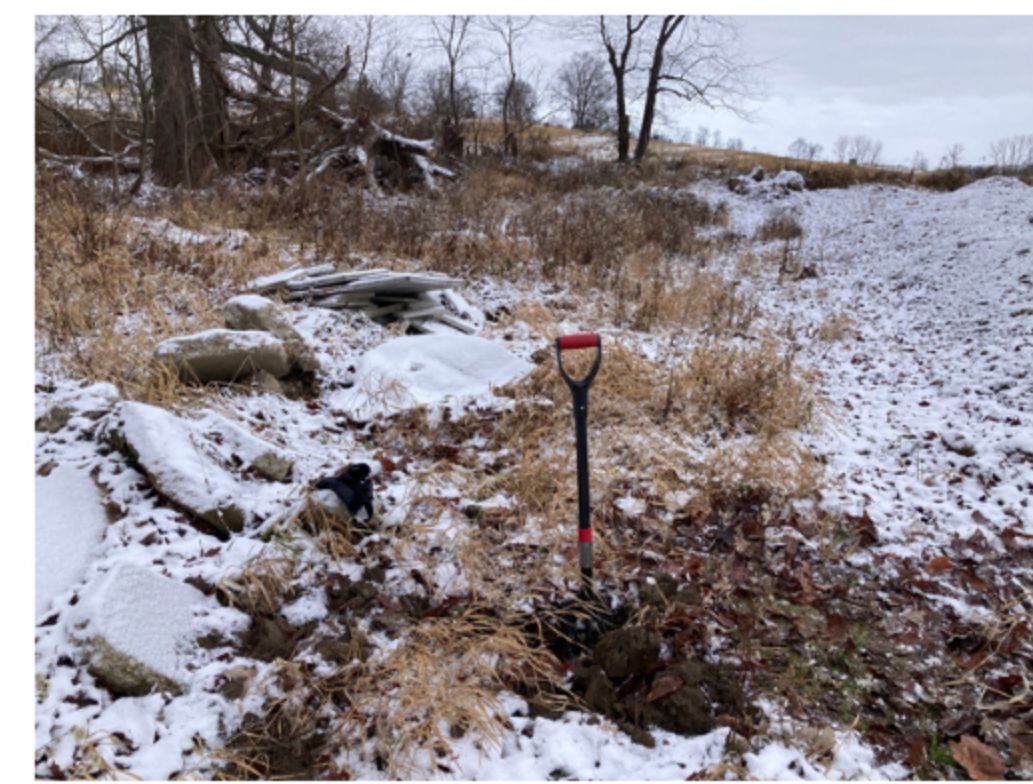
Sample Point 1
Representative of existing undisturbed wetland on-site

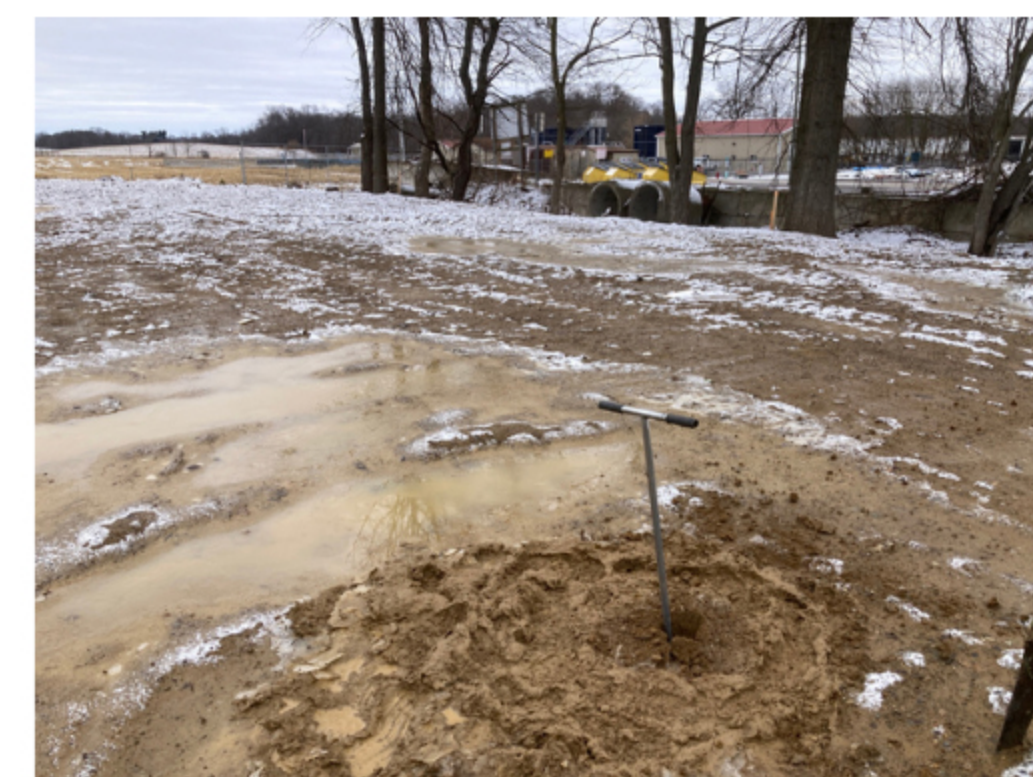
Sample Point 18
Representative of disturbed wetland area on-site

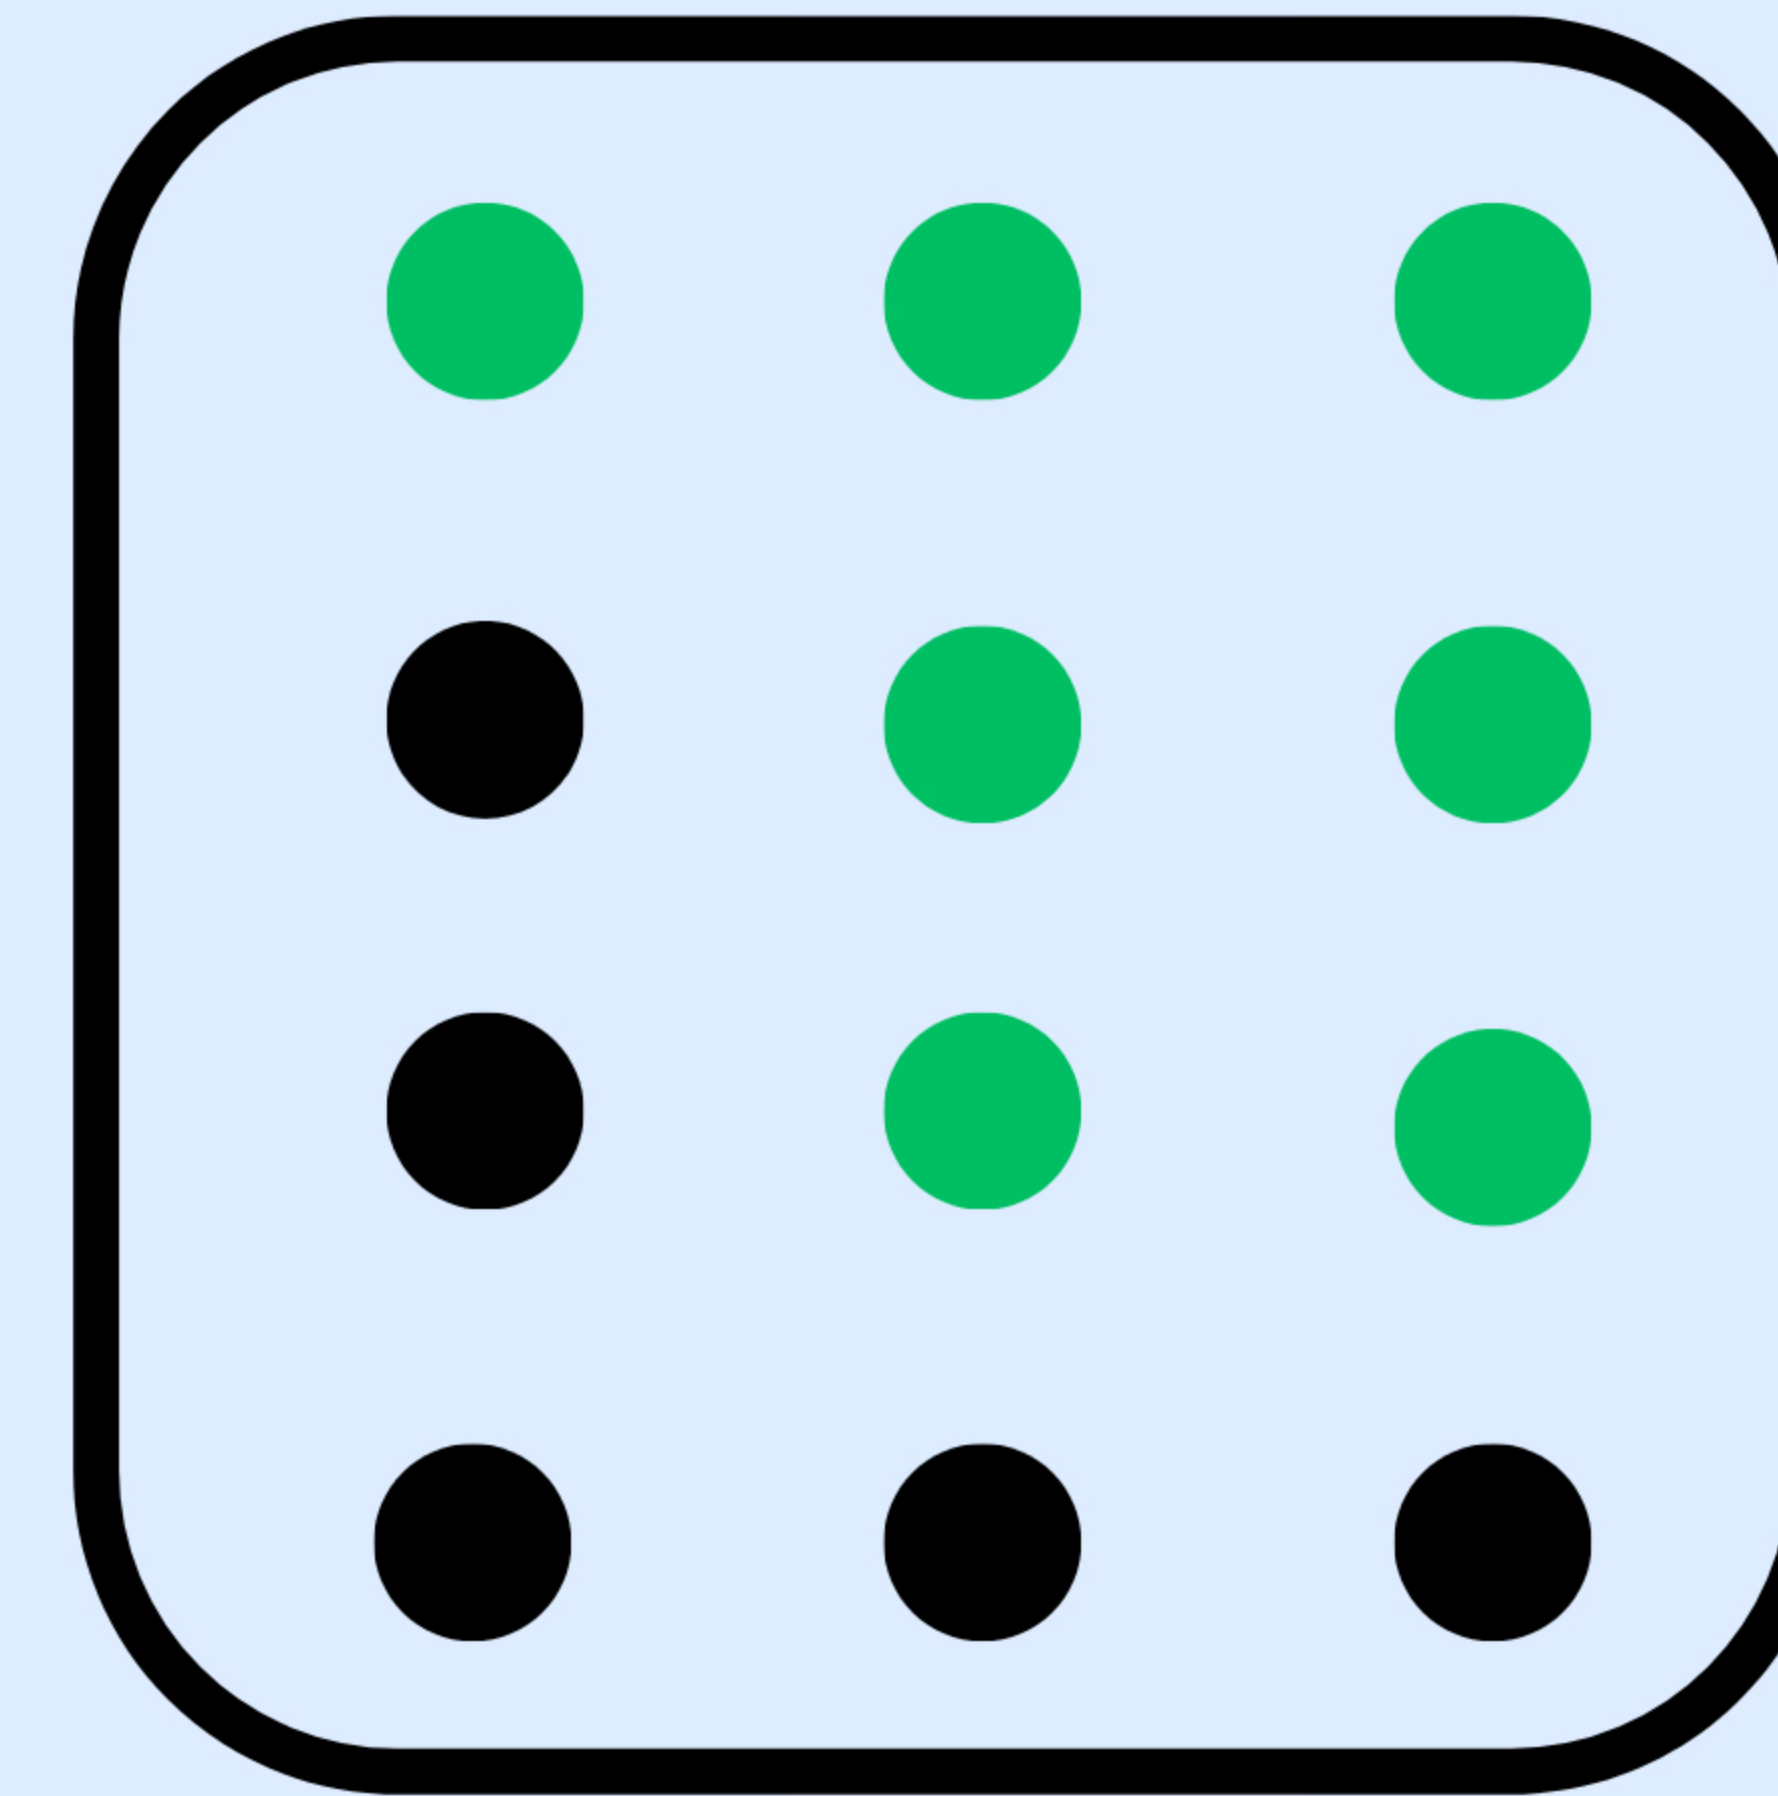
Data Review

- Reviewed sample point data to determine the disturbed wetland boundary
- Sample points with hydric soil indicators were determined to be wetland
- Sample points with no hydric soil indicators were determined to be upland
